COMPOSITE FAILURE ANALYSIS HANDBOOK  
VOL I - PROGRAM OVERVIEW

R.J. Kar  
Northrop Corporation  
One Northrop Avenue  
Hawthorne, California 90250-3277

February 1992

Final Report for Period January 1987 - October 1990

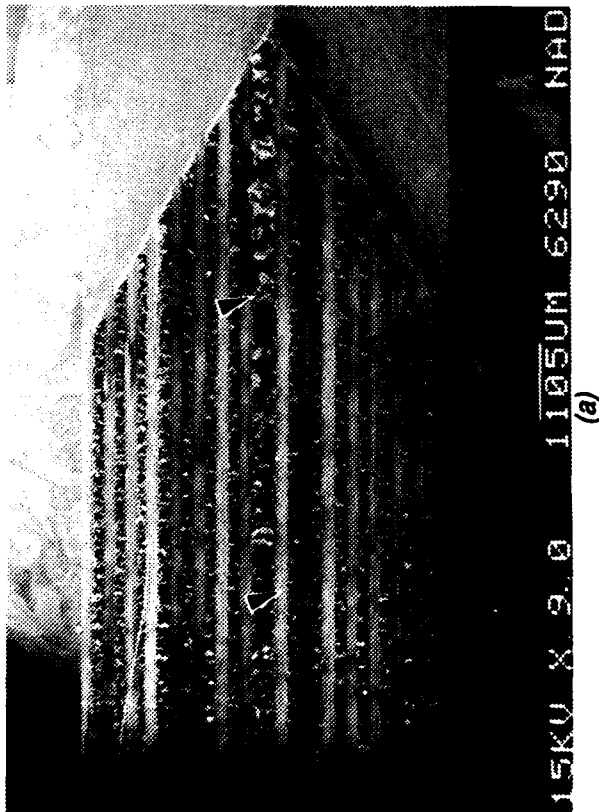
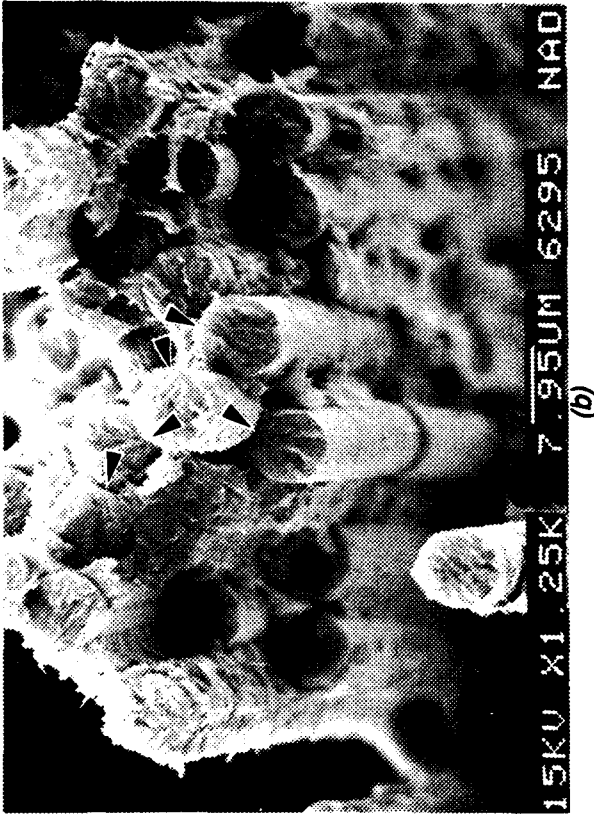
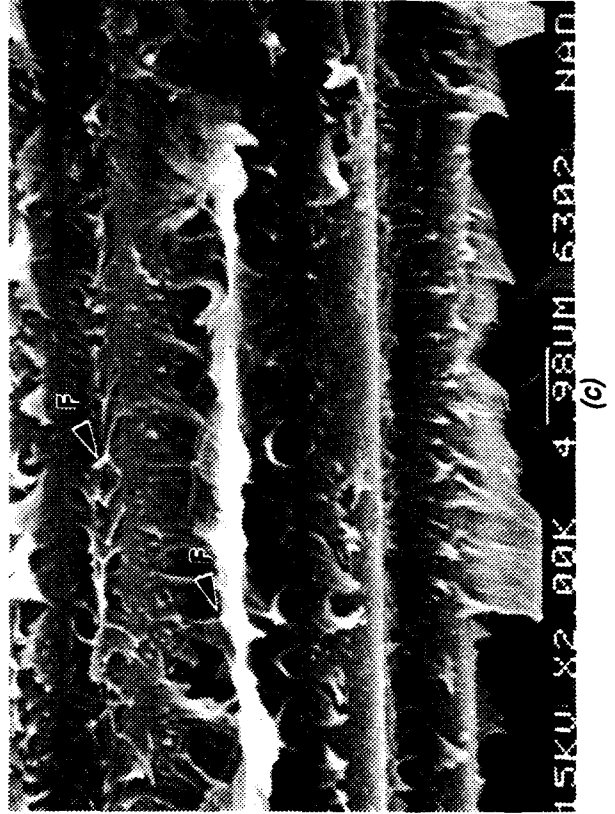
Figure 3-37. SEM Photographs of Mode I Translaminar Tension Fracture in AS4/APC-2 Gr/PEEK - [90/0]<sub>as</sub>  
 (a) Macro photograph Showing Chevrons (Arrows)  
 (b) Fracture in 0 Degree Fibers (Tension Region)  
 (c) Resin Fracture in 90 Degree Plies, Fractured Fibrils (F) Oriented Along CD

Note: Arrows indicate DAF radii.

CD = Crack-propagation direction

**Translaminar Fractography.** Figure 3-37 presents macroscopic and microscopic fracture features in AS4/APC-2 Gr/PEEK tested under Mode I translaminar tension loading. There were no macroscopic differences between the tension and compression fracture regions that normally occur during translaminar testing. However, as shown in Figure 3-37a, fractured fibers in the 0 degree plies resembled gross chevrons that radiated toward the machined notch.

Figures 3-37b and 3-37c show microscopic fracture features in local tensile fracture

regions. Fractured fibers in 0 degree plies (oriented normal to the applied load) were decorated with DAF radials, as previously reported for Gr/Ep. The fractured resin in 90 degree plies (oriented parallel to the applied load) exhibited fractured fibrils that closely resembled river patterns (Figure 3-37c). These could be used to map local crack-propagation direction. The compression fracture regions (away from the machined notch) were characterized by "chop" marks as for Gr/Ep.

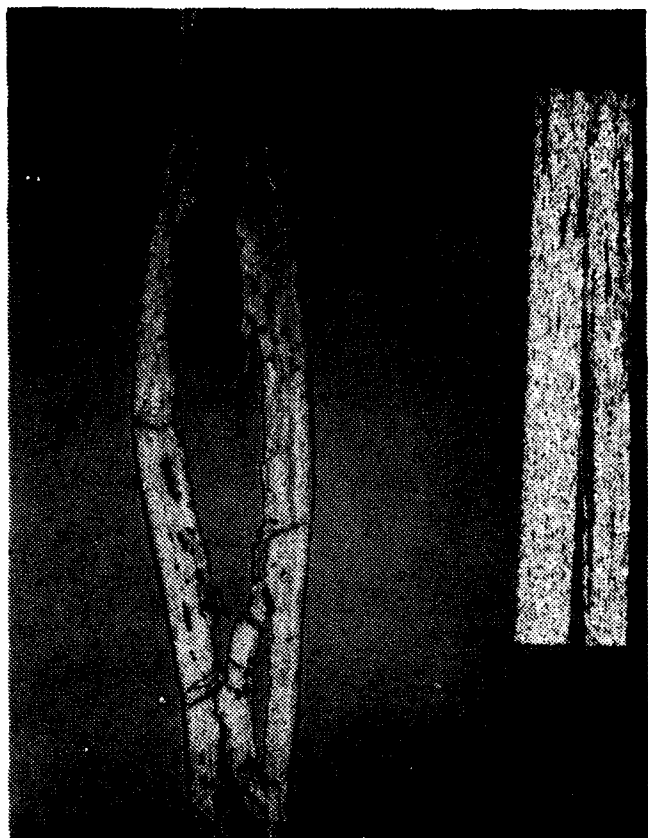
Figure 3-38. Rockwell Flaw Criticality Study Defects  
(a) Defect 1: External Delamination (8.3X)  
(b) Defect 2: Blister, Internal Delamination (6.5X)

Photographs illustrating all the defects documented are shown in Volume II, Part 1 – Procedures and Techniques (Section 2.4). A list of these defects is given in Table 3-13. The corresponding Rockwell study defect number and the stage at which each defect occurs, as defined in the Rockwell study, are also given. Figure 3-38 shows some of the defects documented.

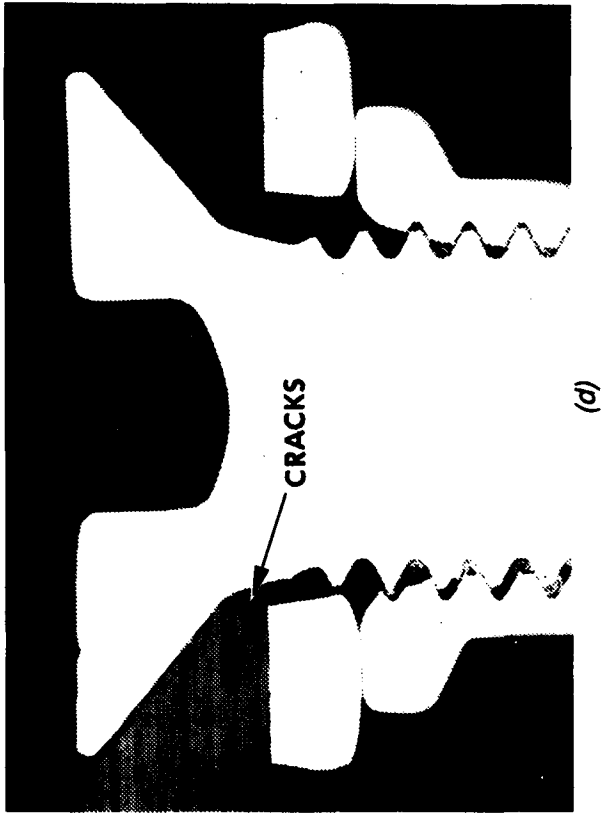
Figure 3-38. (Continued)  
 (c) Defect 13: Splintering, Edge Delamination (2X)  
 (d) Defect 14: Overtorqued Fastener (7X)  
 (e) Defect 16: Edge Notch, Crack (5X)

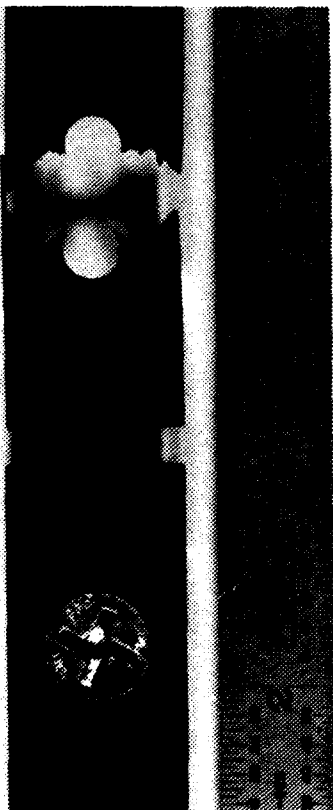
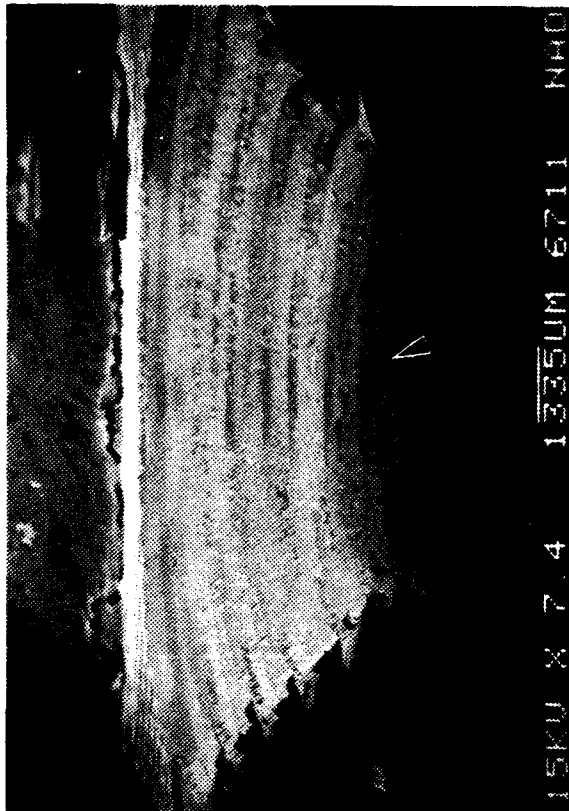
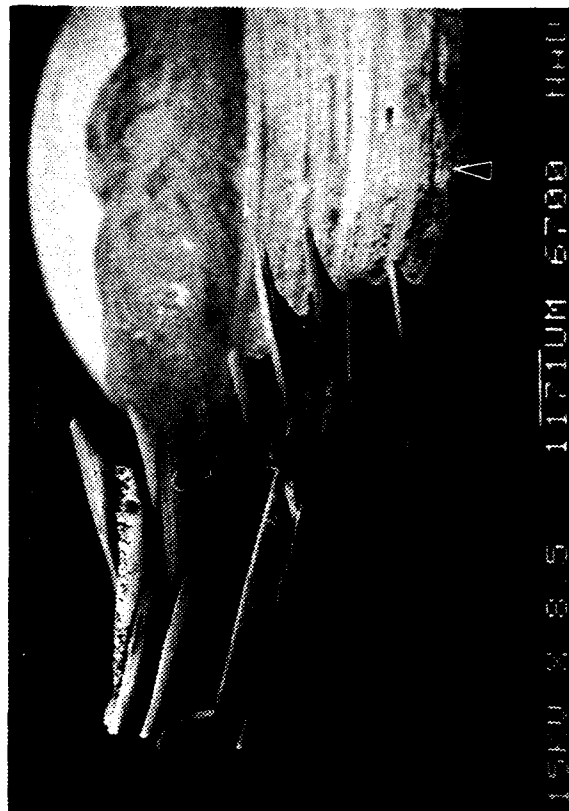
Figure 3-39. Optical and SEM Photographs of Tension Failure in AS4/3501-6 Gr/Ep Bolted Joint  
 (a) Macro photograph of Failed Joint  
 (b), (c) Macro photographs of Failed Adherends  
 Note compression damage (arrows)

Figure 3-39 illustrates fracture characteristics for tension failure. Net-section tension failures occur in mechanically-joined composite specimens with small  $w/d$  and large  $e/d$  ratios ( $w$  = composite width,  $d$  = fastener diameter, and  $e$  = distance of fastener from edge). This failure mode was achieved using  $w/d$  and  $e/d$  ratios of 3 and 3, respectively, using 32-ply quasi-isotropic AS4/3501-6 Gr/Ep adherends, and a tension head "Hi-Lok" titanium fastener with a head diameter of 0.25 inches. In this type of failure, fracture occurs due to insufficient specimen width.

Figures 3-39b and 3-39c show macrographs of mating halves of the adherends in the vicinity of the machined hole. Examination of peripheral regions of the bolt-hole revealed compression characteristics indicating that failure in the joint region was a compression dominated event.

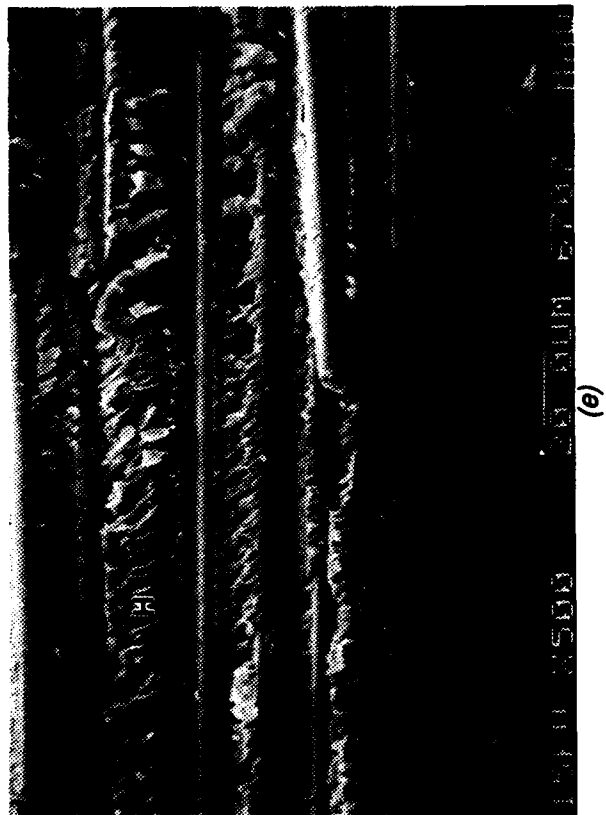
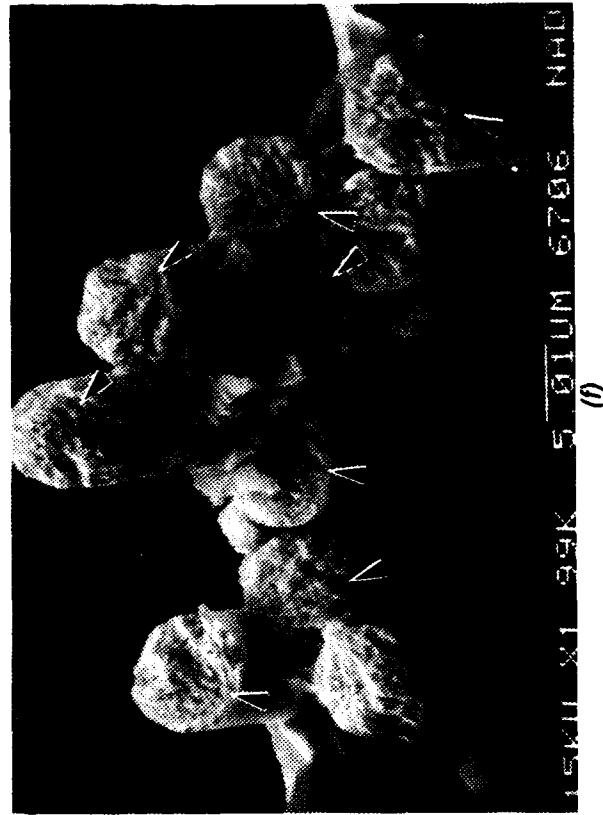
Figure 3-39. (Continued)  
 (d), (e) Hackles (H) in 90 and 45 Degree Plies  
 (f) DAF Radials on 0 Degree Fibers

Figures 3-39d, 3-39e and 3-39f illustrate microscopic fracture characteristics in 90, 45, and 0 degree plies. The 90 and 45 degree plies were characterized by hackles (Figures 3-39d and 3-39e), and "chop" marks on fiber ends indicating that these plies had failed in shear. The 0 degree plies were associated with translaminar tension features, namely DAF radials (Figure 3-39f), that appeared to originate from adjacent 45 degree plies rather than the bolt-hole.

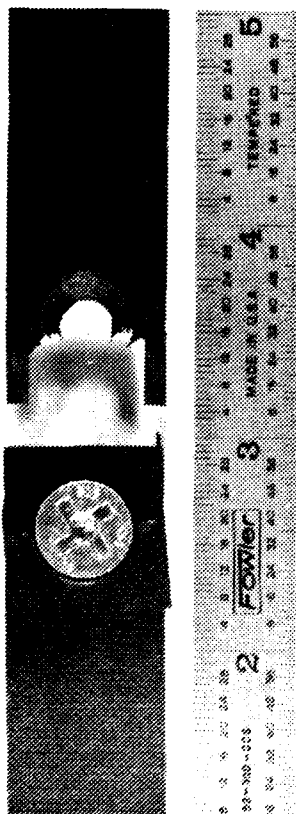
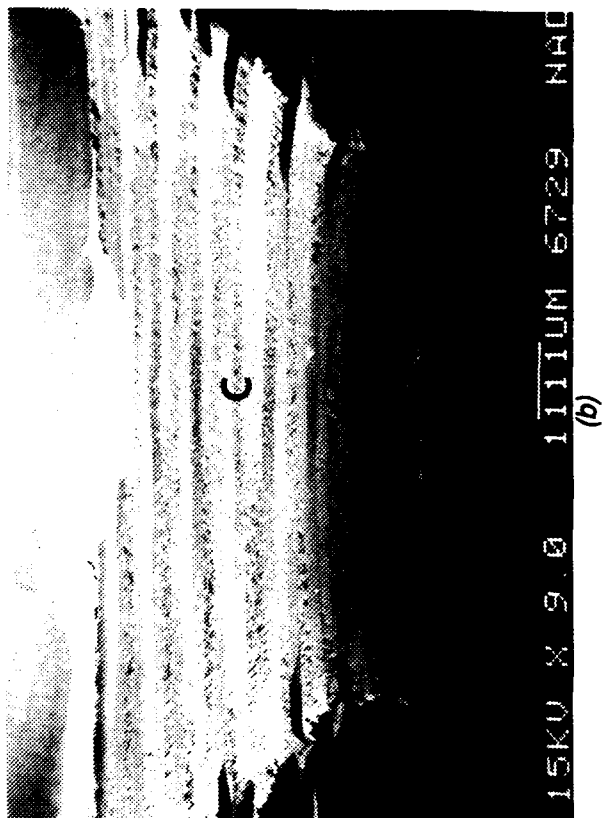
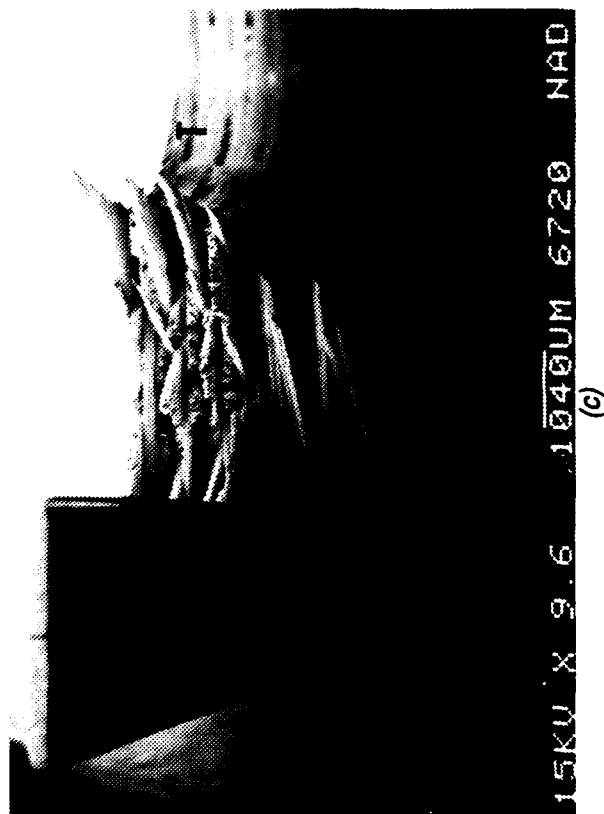
Figure 3-40. Optical and SEM Photographs of Tension-Cleavage Failure in AS4/3501-6 Gr/Ep Bolted Joint  
(a) Macro photograph of Joint  
(b), (c) Macro photographs of Peripheral Regions of Bolt-Hole in Mating Halves

Figure 3-40 illustrates macroscopic fracture characteristics for tension-cleavage failure. It is believed that the bolted joint failed in this manner due to the shear-out and net-section failure strengths of the joint being similar. The failure was achieved using  $w/d$  and  $e/d$  ratios of 3 and 2 respectively ( $w$  = specimen width,  $e$  = fastener to edge distance,  $d$  = fastener diameter).

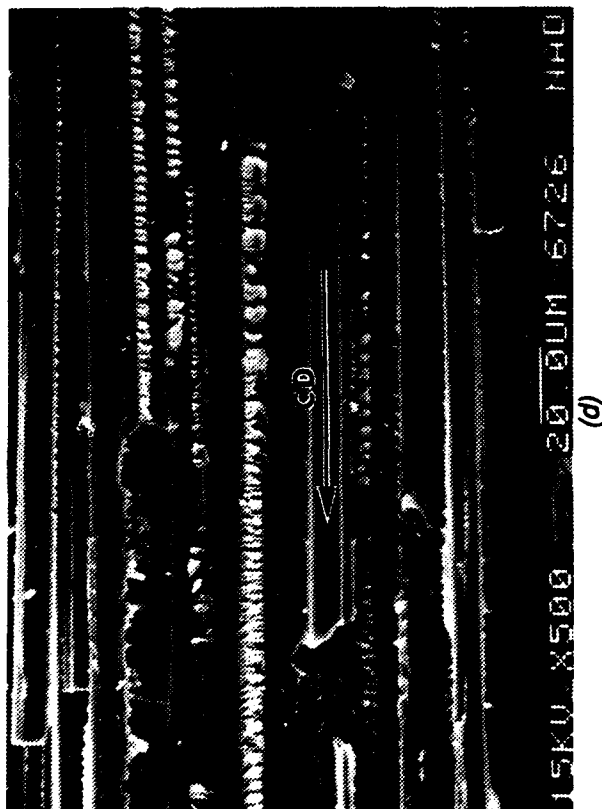
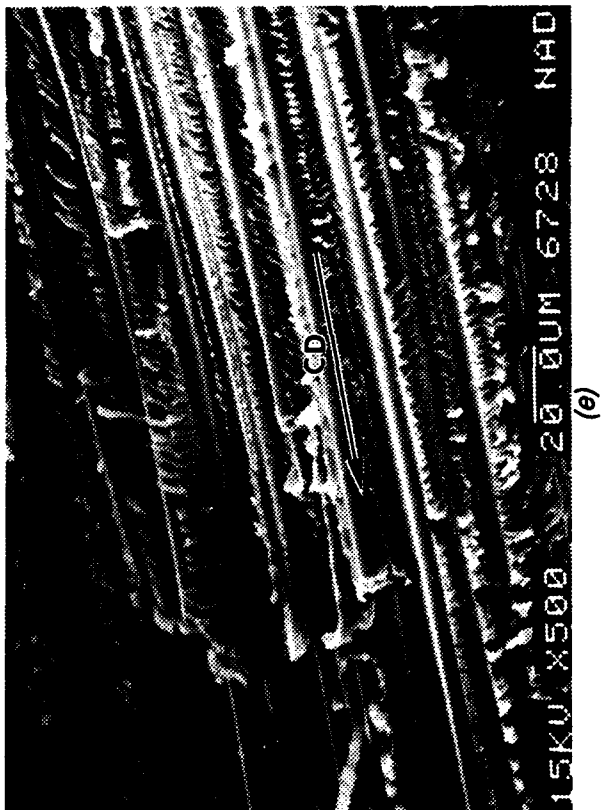
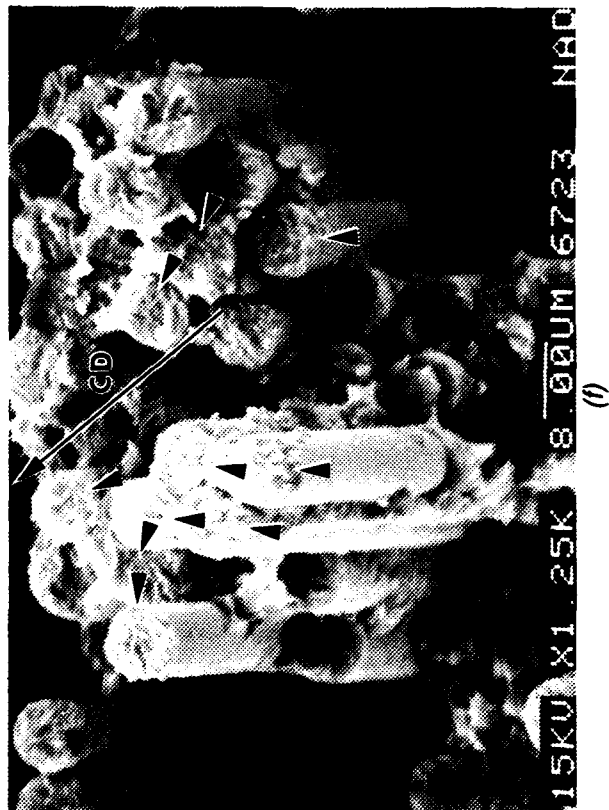
Figure 3-40. (Continued)  
 (d) Translamellar Fracture in 90 Degree Ply in Tensile  
 Fracture Region  
 (e) Fracture in 45 Degree Ply  
 (f) Tensile Fracture in 0 Degree Ply  
 Note DAF radials (Arrows)

Figures 3-40d, 3-40e, and 3-40f illustrate microscopic fracture characteristics in 90, 45, and 0 degree plies. Catastrophic translaminar fracture initiated in 90 degree plies in tensile regions of the bolt hole and propagated radially outward, as determined by mapping of the rivers in the fractured resin (Figure 3-40d). This was followed by combined inter/translaminar fracture in the  $\pm 45$  plies (Figure 3-40e), and translaminar fracture in the 0 degree plies. Mapping of the DAF radials in 0 degree plies (Figure 3-40f) indicated that fracture in these regions had originated at adjacent 45 degree plies, rather than at the periphery of the hole.

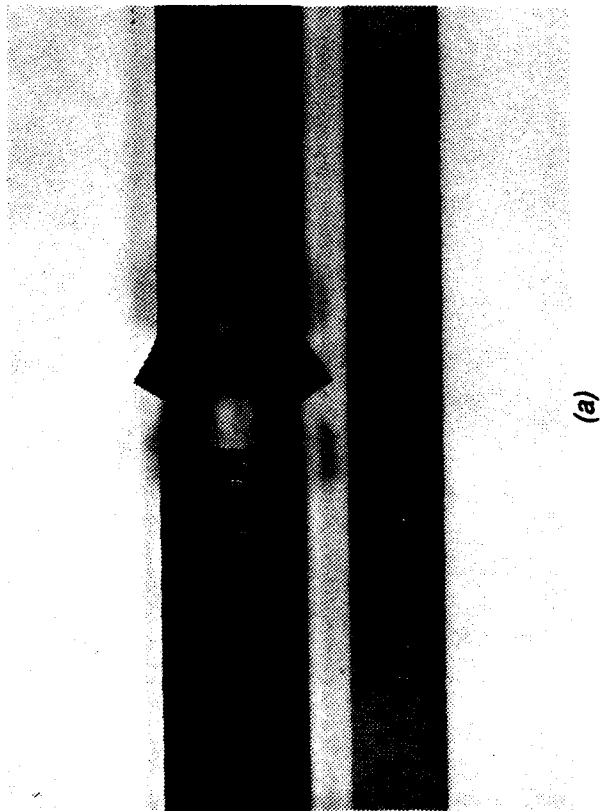
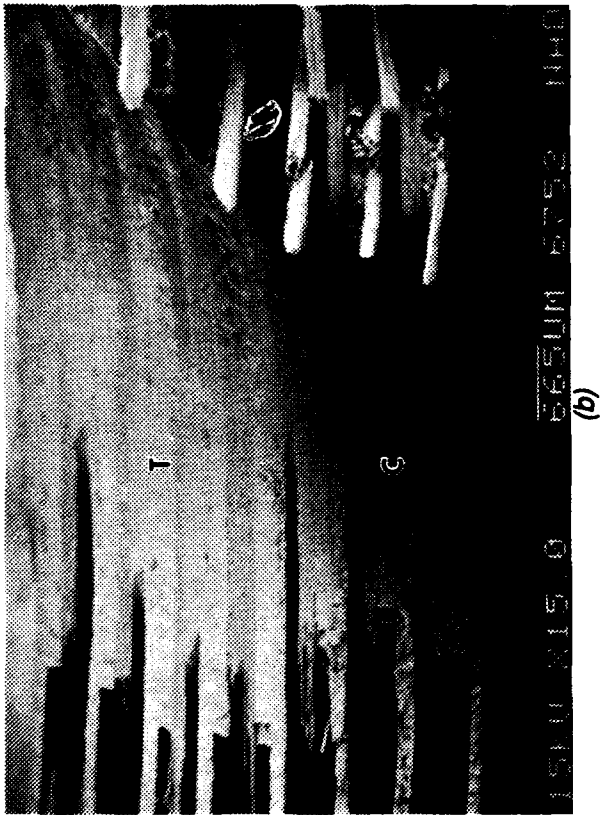
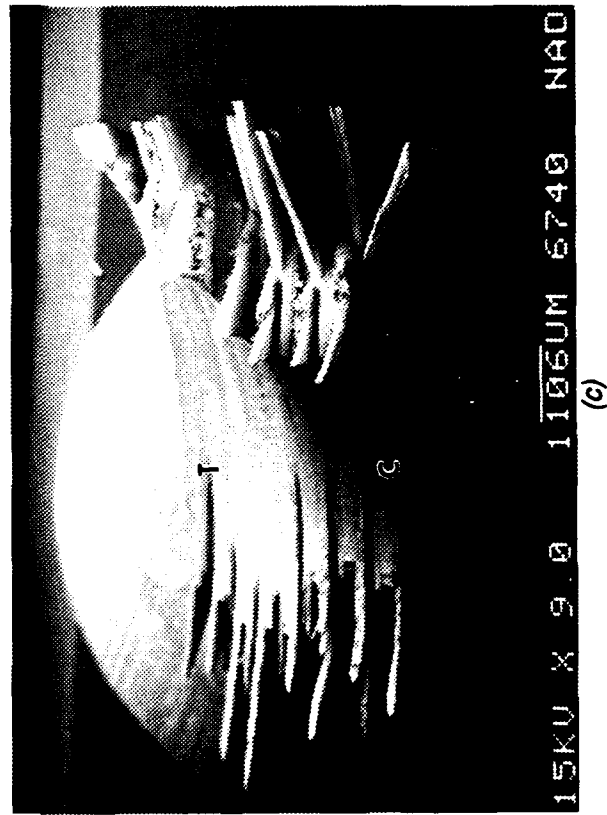
Figure 3-41. Optical and SEM Photographs of Shear-Out Failure in AS4/3501-6 Gr/Ep Bolted Joint  
 (a) Macro photograph of Failed Joint  
 (b), (c) Macro photographs of Failed Adherends  
 Note compression (C) and tension (T) regions

Figure 3-41 shows photographs illustrating shear-out failure. This failure mode occurred due to small edge distances, i.e. small  $e/d$  ratios with concomitant large  $w/d$  values ( $e/d = 1.5$ ,  $w/d = 3$ ).

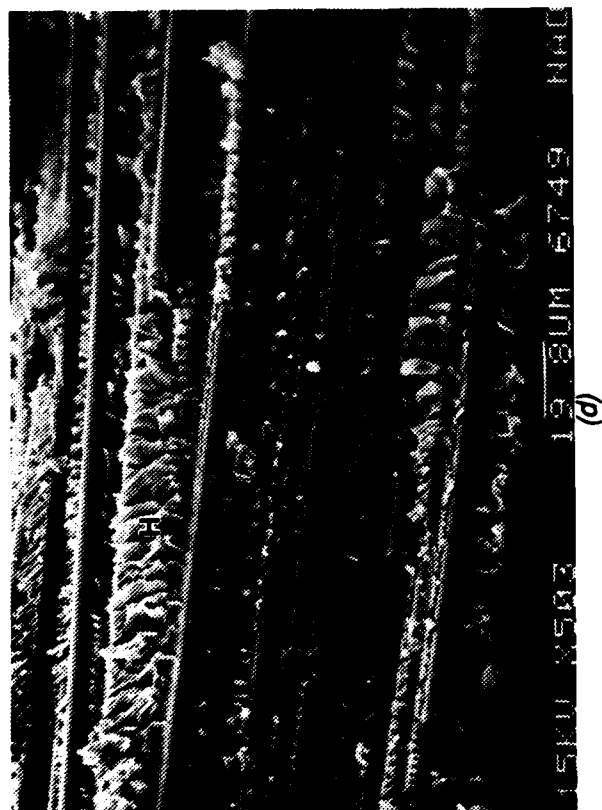
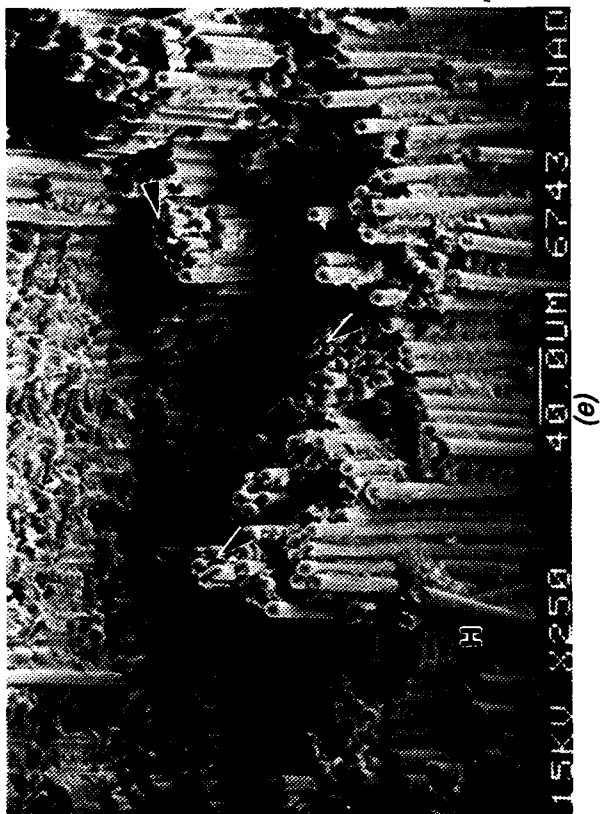
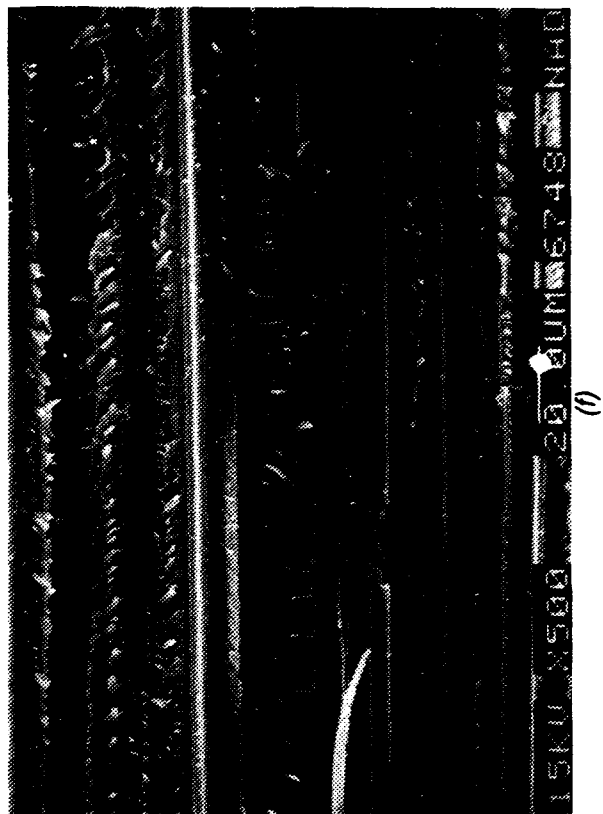
Figure 3-41. (Continued)  
 (d) Hackles (H) in 45 Degree Plies  
 (e) DAF Radials (Arrows) and Hackles (H) in 0 Degree Plies  
 (f) Peel Characteristics in 90 Degree Plies

Macroscopic examination of the peripheral regions of the hole revealed that the non-chamfered regions were associated with compression damage. The 45 degree plies were characterized by hackles on fractured resin (Figure 3-41d) and chop marks on fiber ends, indicating failure due to shear loads. The 0 degree plies exhibited DAF radials and hackles on fractured resin (Figure 3-41e) as would occur under "in-plane" shear. The 90 degree plies had failed in peel originating away from the bolted joint rather than at the joint (Figure 3-41f).

Based on these observations it appears that on loading of the joint, failure initiated due to compression loads in non-chamfered regions of the hole. The 45 degree plies failed under shear with subsequent in-plane shear failure of the 0 degree plies, and final failure of the 90 degree plies in peel.

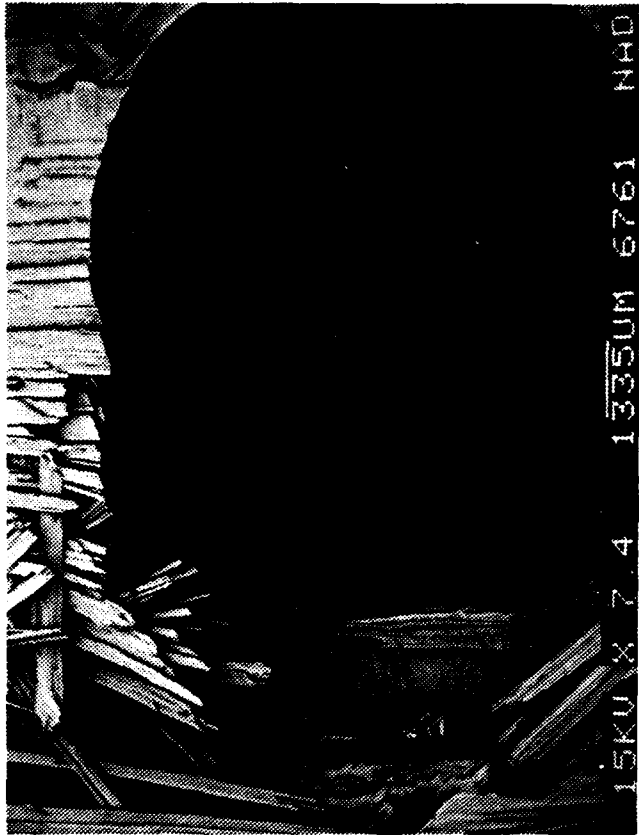
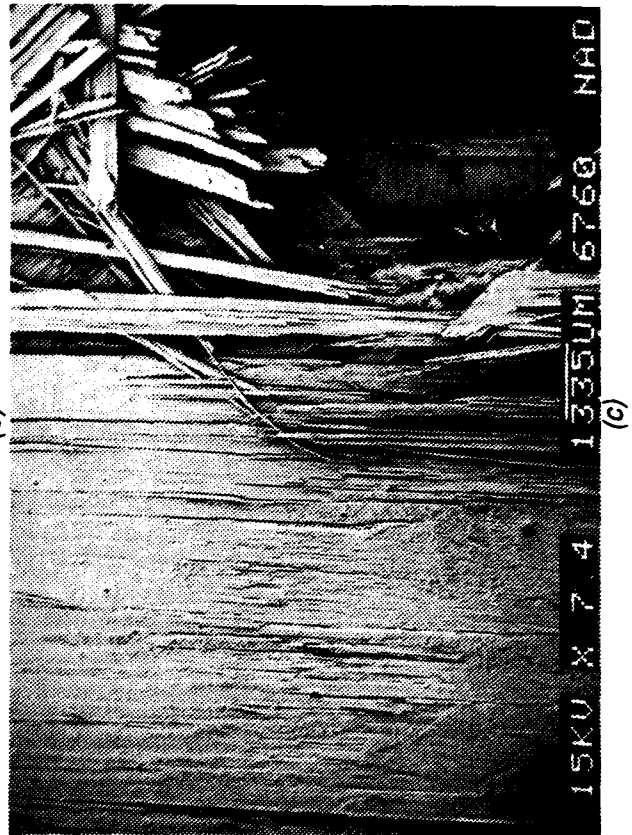
Figure 3-42. Optical and SEM Photographs of Bearing Failure in AS4/3501-6 Gr/Ep Bolted Joint  
 (a) Macro photograph of Failed Joint  
 (b) Detail Near Bolt-Hole  
 (c) Fractured Adherends

Bearing failures are the preferred failure mode for most joint applications since "local" yielding of the material occurs in this mode, with the surrounding material remaining intact. Figures 3-42a through 3-42f illustrate this failure mode which occurred in specimens with  $e/d$  and  $w/d$  ratios of 5 and 3.5. In quasi-isotropic Gr/Ep, this failure mode has been reported to occur for  $w/d$  ratios greater than 5 and  $e/d$  ratios greater than 3 (Reference 1).

Macroscopic examination of the bolt-hole revealed that peripheral regions not subjected to the local bearing load had failed under in-plane shear, as indicated by the fiber splits and DAF radials on broken fiber ends (Figure 3-42c). Examination of the 45, 90, and 0 degree plies revealed pronounced hackle formation in the fractured resin as would occur under shear loading (Figure 3-42d through 3-42f). These observations indicate that during loading of the joint, local regions in the bolt-hole failed under compression, with subsequent fiber-splitting and delaminations across the adherends under shear loads.

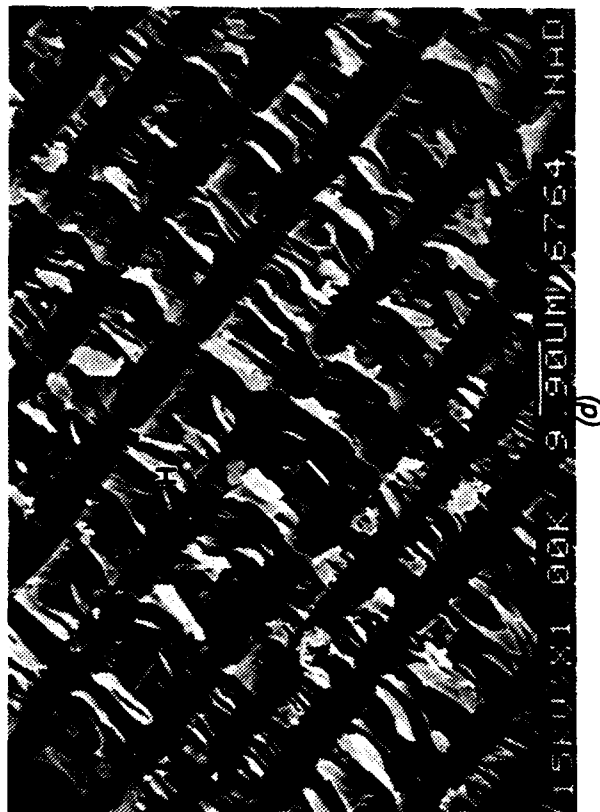
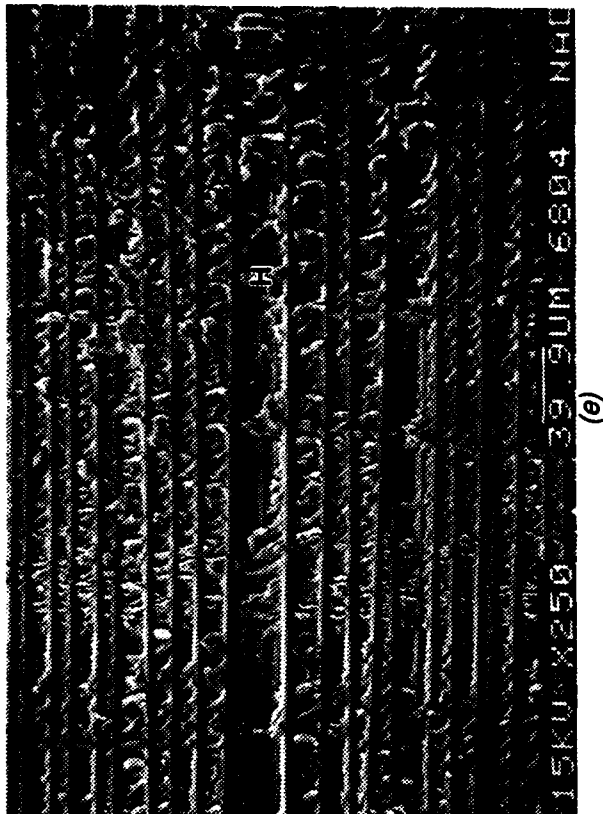
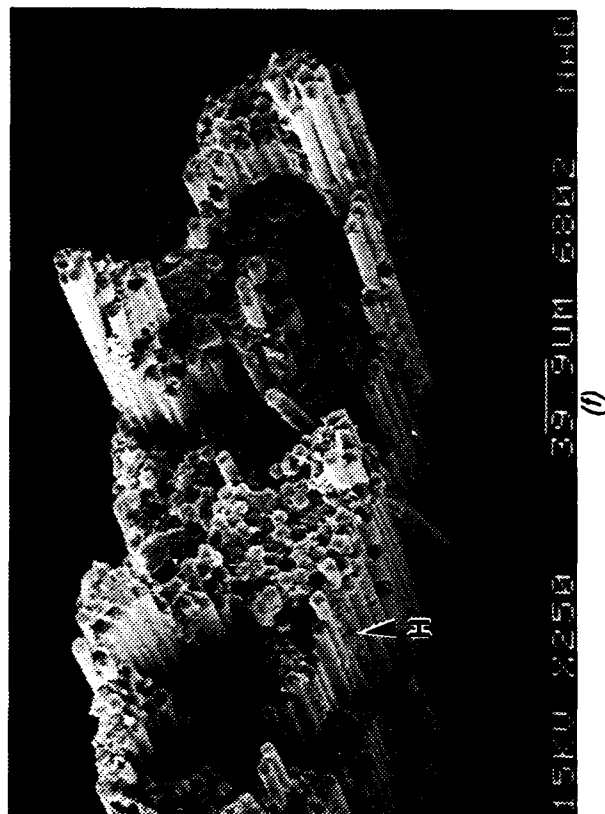
Figure 3-42. (Continued)  
(d), (e), (f) Hackles (H) in 45, 90, and 0 Degree Plies

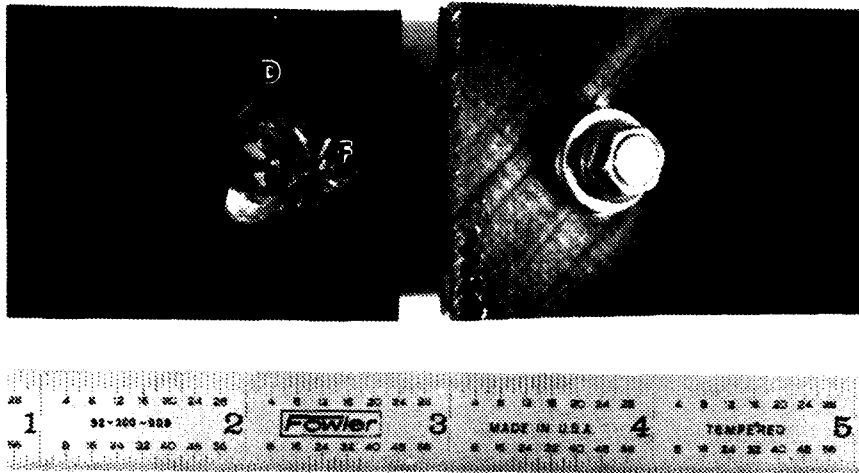
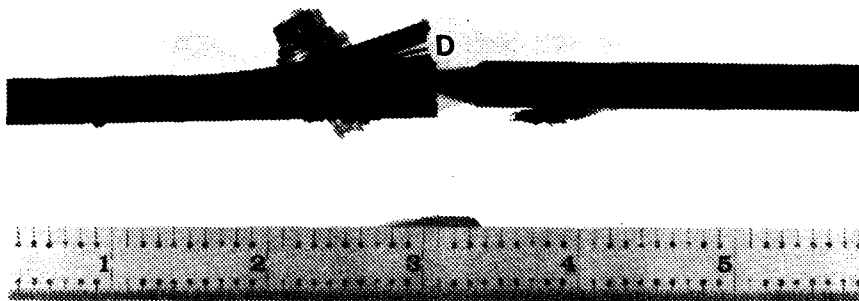
**Figure 3-43. Optical and SEM Photographs of Bolt Failure in AS4/3501-6 Gr/Ep Bolted Joint**  
**(a), (b) Macrophotographs of Fracture**  
 Note fiber crush (F) and delamination (D)

Figure 3-43 provides photographs illustrating bolt failure. This failure mode occurred due to excessive bending of the joint, and was achieved by using  $w/d$  and  $e/d$  ratios of 6 and 3, respectively. Macroscopic failure consisted of 1) bolt fracture, 2) crushing of fiber bundles due to bearing loads, and 3) delaminations along 45 degree plies. SEM examination of the crushed regions revealed compression failure characteristics. The delaminations exhibited shear characteristics (Figure 3-43d).

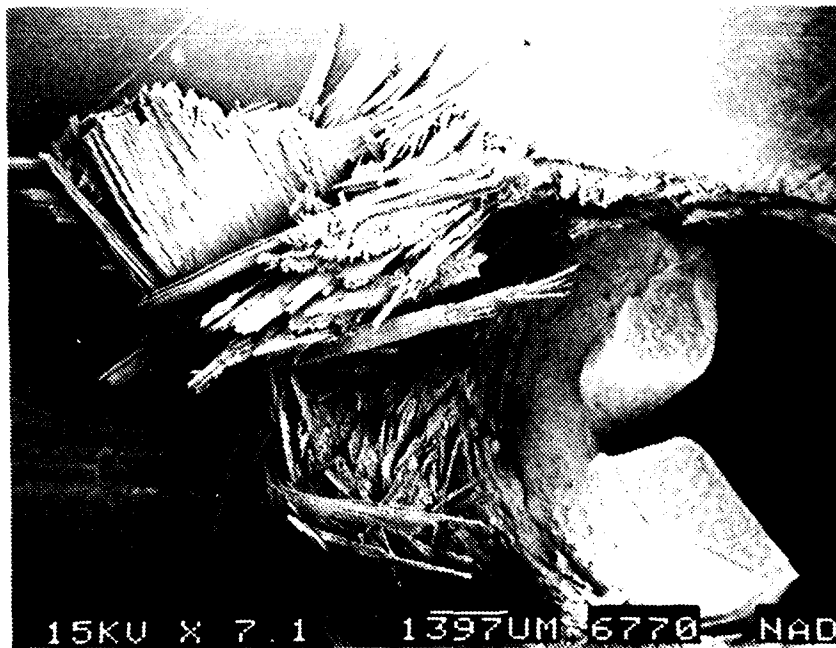
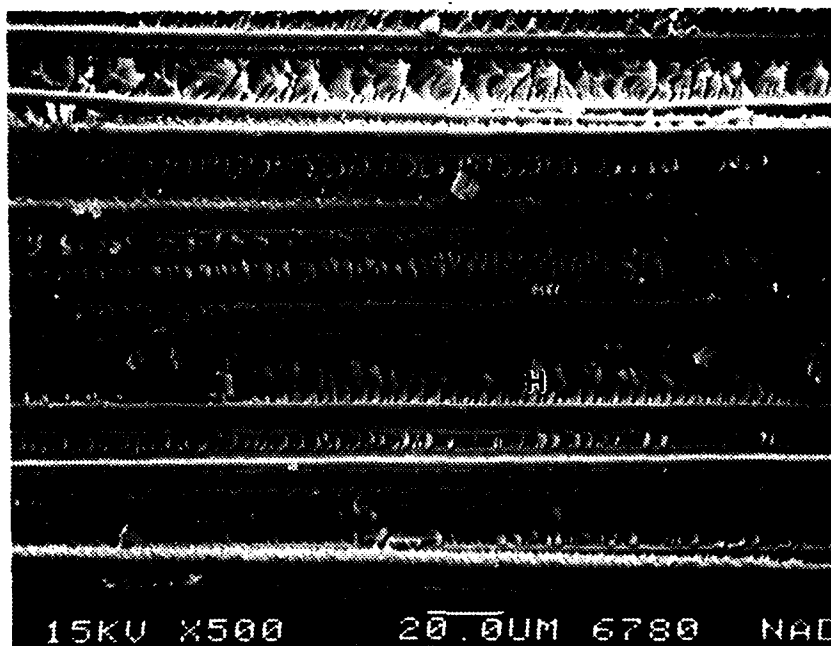
Figure 3-43. (Continued)

(c) Fracture Detail in Fiber Crush Region

(d) Shear Fracture in Delamination Region

Note hackles (H)

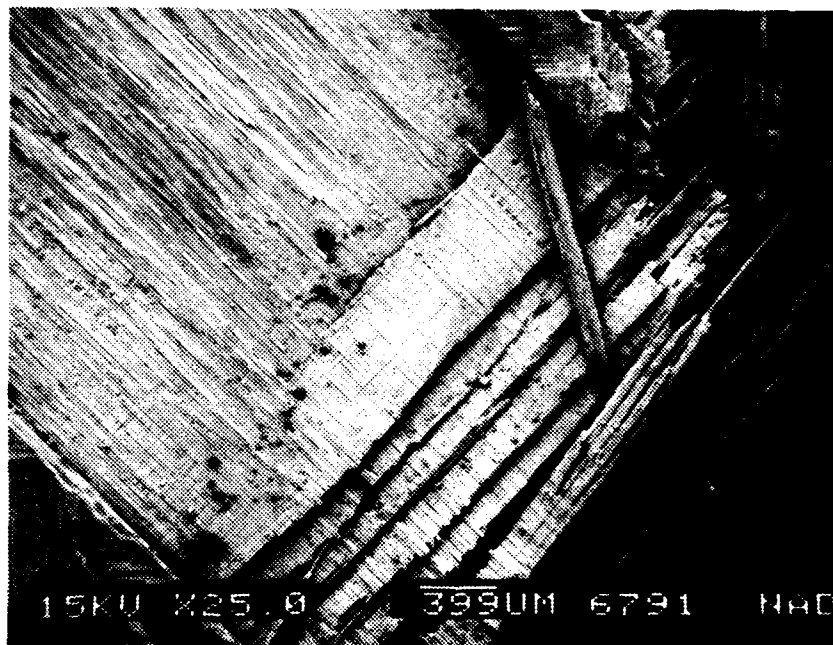
**Figure 3-44. Optical and SEM Photographs of Bolt Hole Pull Through in an AS4/3501-6 Gr/Ep Bolted Joint**  
**(a) Macrophotograph**  
 Note delamination in adherends (arrow)  
**(b) Low Magnification of Peel Fracture in Surface Delamination**

Figure 3-44 provides photographs of this failure mode. Fastener pull through occurred because the depth of countersinking exceeded 70 percent of the bolted joint thickness ( $w/d = 6$ ,  $e/d = 3$ , 8 ply quasi-isotropic adherends).

Macroscopic failure consisted of delaminations in the outer plies that initiated at the machined bolt hole. The microscopic fracture features for this failure mode are shown in Figures 3-44b, 3-44c, and 3-44d. Delamination occurred by peel (Mode I tension and Mode II shear). Mapping of the rivers indicated fracture initiation at the periphery of the hole with radial propagation in an interlaminar manner.

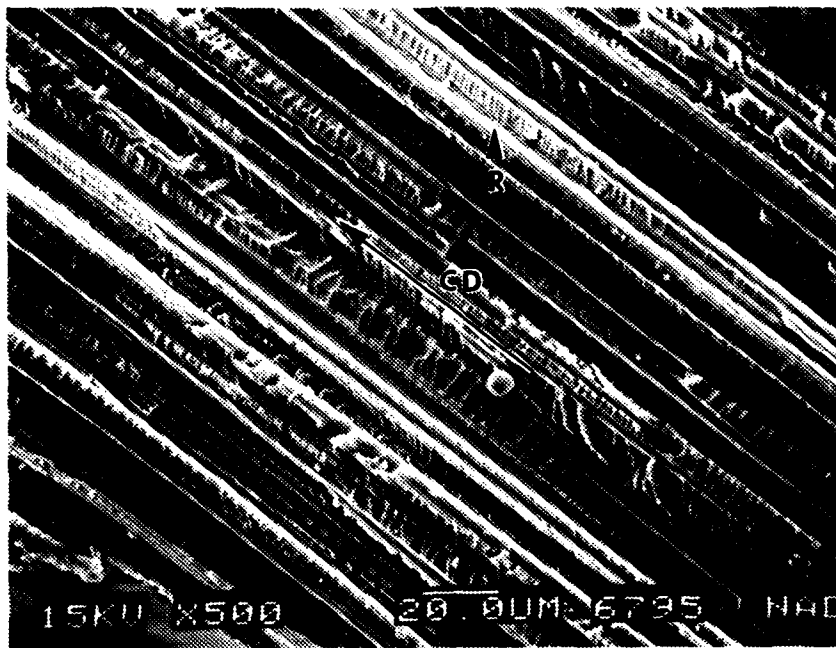
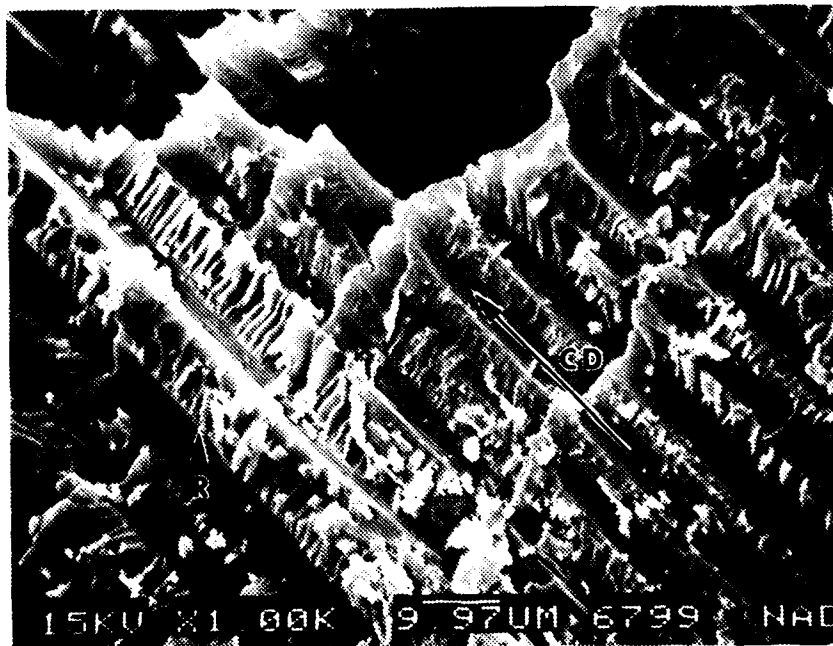
**Figure 3-44. (Continued)**

**(c) Intermediate Magnification of Peel Fracture in Surface Delamination**

**(d) Peel Fracture in an Internal Delamination**

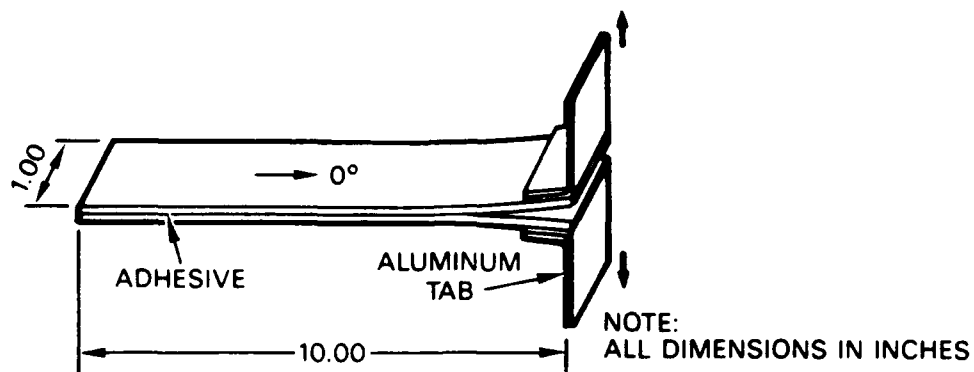
Figure 3-45. Double-Cantilever Beam Specimen

The adhesively joined structures were tested under simple Mode I tension, Mode II shear, or mixed-Mode I tension plus Mode II shear loading. Northrop used double-cantilever beam, and unconstrained and constrained cracked-lap shear specimens, shown in Figures 3-45 through 3-47.

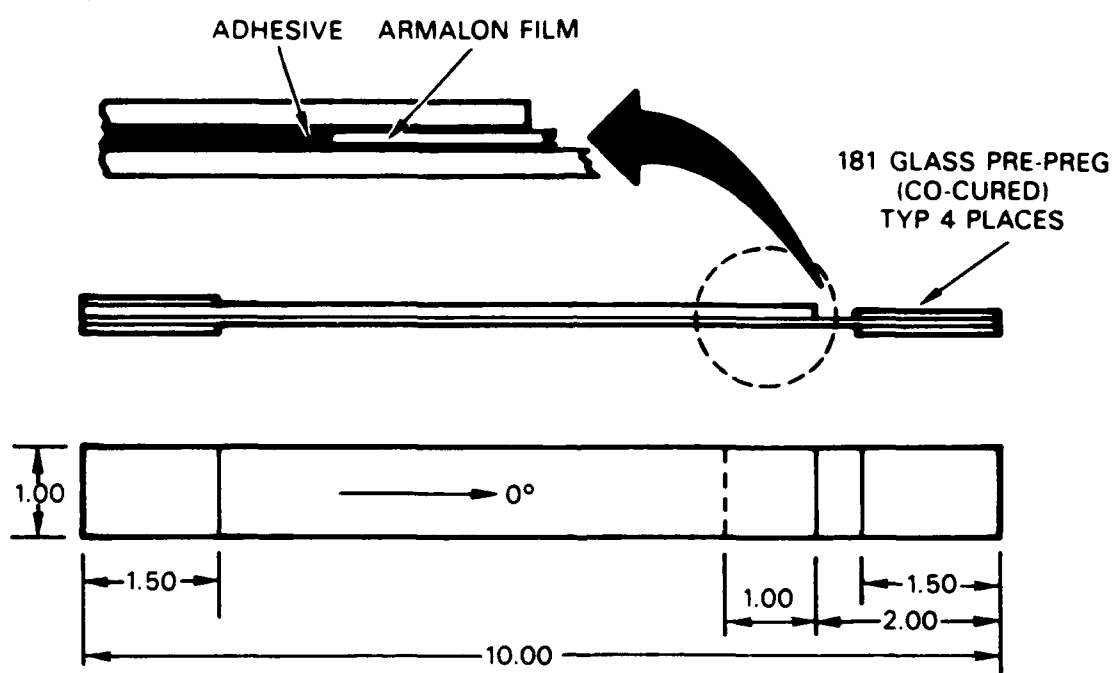
Figure 3-46. Cracked-Lap Shear Specimen

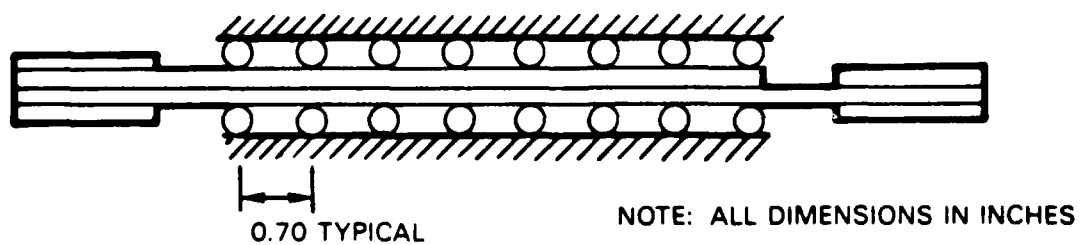
Figure 3-47. Constrained Cracked-Lap Shear Specimen

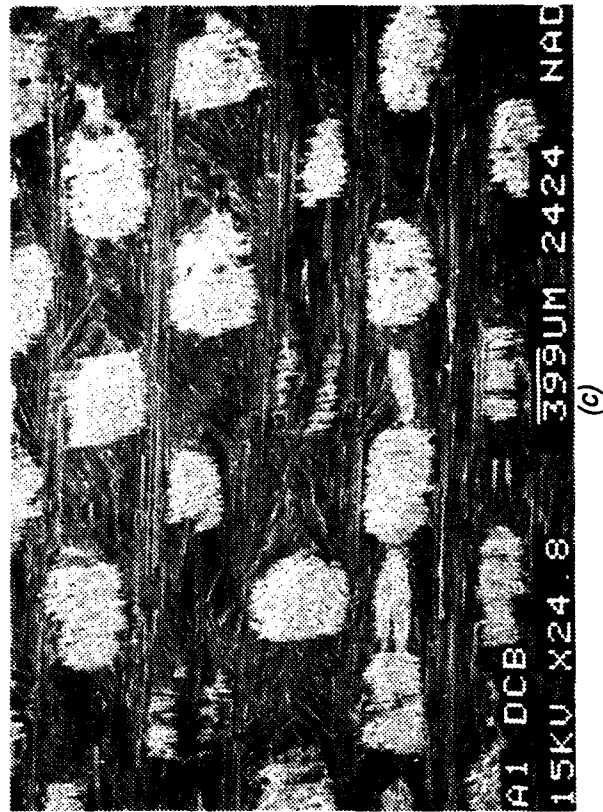
**Figure 3-48. Optical and SEM Photographs of Failure in Unidirectional AS4/3501-6 Gr/Ep Adherends Bonded With FM 300 Adhesive and Tested Under Interlaminar Mode I Tension**  
**(a) Macro photograph**  
**(b) Low Magnification (4X) Photograph Showing Failure Detail**  
**(c) Adhesive Failure Region**

A = Adhesive failure  
 C = Cohesive failure  
 CD = Crack propagation-direction

Figure 3-48 presents photographs of fracture for unidirectional Gr/Ep adherends bonded with FM-300 adhesive, and tested to failure under interlaminar Mode I tension. On a macroscopic scale, fracture initiated in a "cohesive" manner and then changed to an "adhesive" mode (Figures 3-48a, 3-48b, and 3-48c).

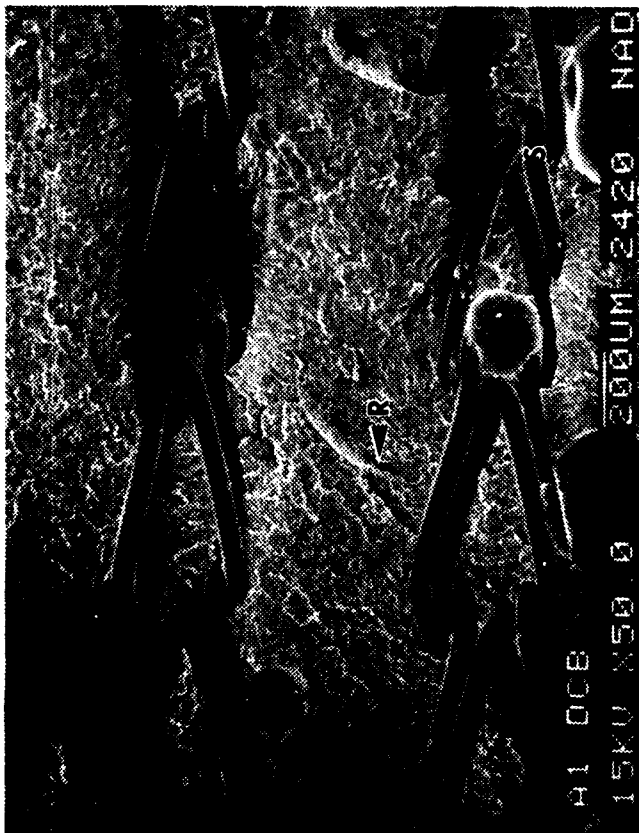
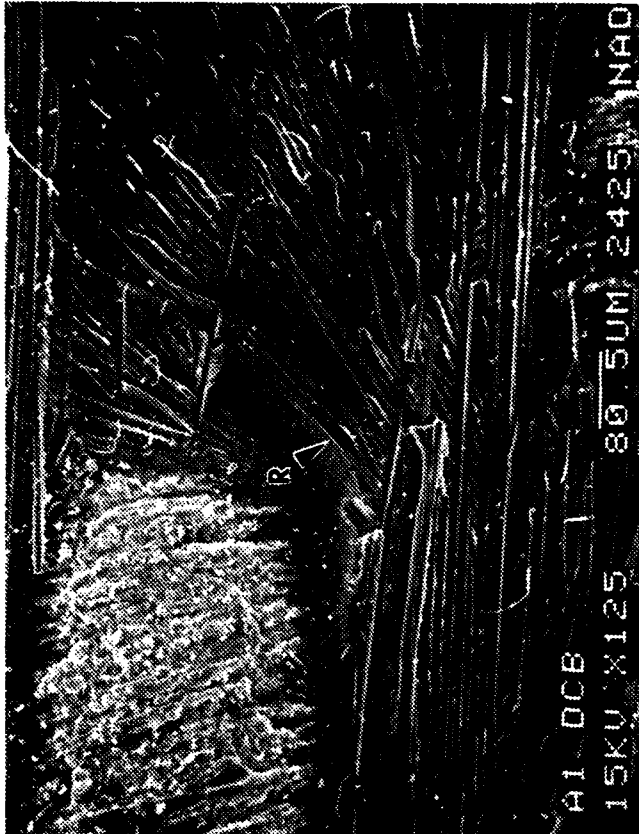
Figure 3-48. (Continued)

(d) River Patterns (R) in Fractured Adhesive in Cohesive Failure Area  
(e) River Patterns (R) in Fractured Epoxy in Adhesive Failure Region

Figures 3-48d and 3-48e show SEM photographs of the cohesive and adhesive failure regions. The fractured adhesive in the cohesive failure region was characterized by stray river patterns (Figure 3-48d) oriented toward the direction of crack-propagation. Fracture could be mapped in the adhesive failure regions through mapping of the rivers in the fractured epoxy of the Gr/Ep adherend (Figure 3-48e).
